Arborist Report & Oak Tree Assessment

4049 Granite Drive, Rocklin, CA

May 2018

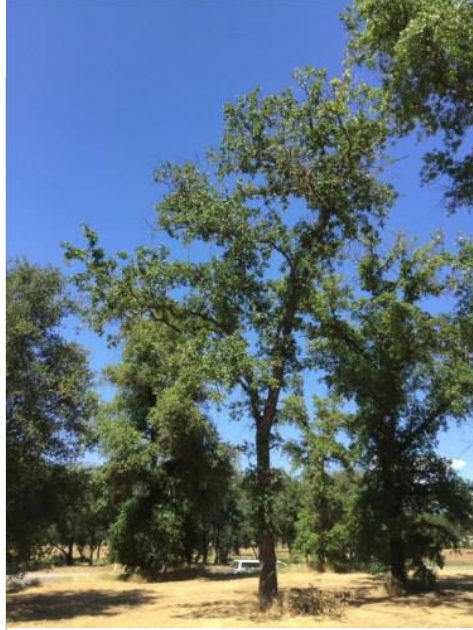
Oak, Valley Tag #: 260
Quercus lobata

260	514	Oak, Valley	Quercus lobata	13.2	60% - Fair	Deadwood, Epicormic Sprouts, Minor Canopy Dieback, Tussock Moth Presence
261	513	Oak, Valley	Quercus lobata	15.1	40% - Poor	Canopy Dieback, Epicormic Sprouts Throughout, Limb Failures, Poor Structure, Tussock Moth Presence
262	N/A	Oak, Valley	Quercus lobata	12.1	80% - Good	Deadwood, Minor Canopy Dieback, Tussock Moth Presence
263	529	Oak, Valley	Quercus lobata	11.2	60% - Fair	Canopy Dieback, Deadwood
264	N/A	Oak, Valley	Quercus lobata	10.8	80% - Good	Co-Dominant Leader with Included Bark, Coast Live Oak Sucker, Minor Deadwood, Powdery Mildew, Tussock Moth Presence
265	528	Oak, Valley	Quercus lobata	16.8	60% - Fair	Deadwood, Epicormic Sprouts, Minor Canopy Dieback, Tussock Moth Presence
